INVESTIGATION REGARDING BRIDGE GIRDER DETERIORATION IN PAKISTAN AND ITS REMEDIAL MEASURES

ABSTRACT: *In highway infrastructure concrete bridges are playing a very important role. A case study of Pakistan is presented in this paper. The main problems that Pakistan is facing regarding bridges is their deterioration from last 20 years. The major reasons for deterioration is variation in specified construction methods and the lack of maintenance. National Highway Authority (NHA) Pakistan owns 6000 bridges on national highways and a number of other bridges across the country. According to a general survey about 30 percent of these bridges are not according to the ASHTOO standards. The total worth of these bridges are about 600 billion Pak rupees. The NHA budget for year 2009 was Rs 39.9 billion. This amount is insufficient to apply the standard procedures of maintenance and retrofitting in order to repair the non-functional bridges in the country. This research is mainly focused on case studies that involve damages and defects of bridge bearings only. Paper addresses all the root causes, remedial measures and recommendations regarding focused issue. This article will help nationwide en

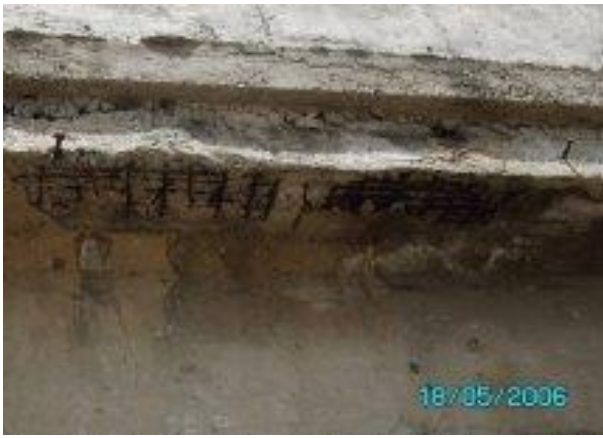
Figure 1 Exposed Reinforcement

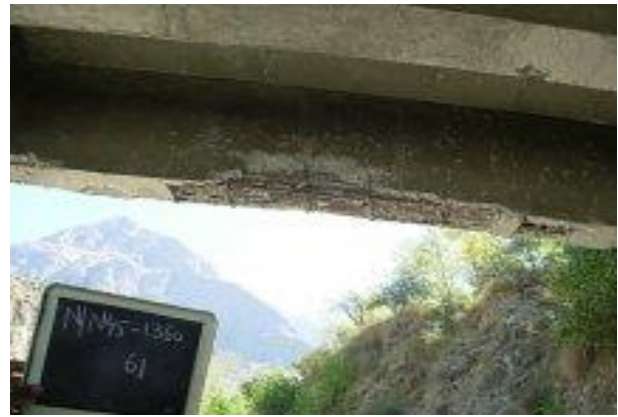
Figure 4 Concrete Deterioration in Girders

1. The scupper pipes should be located at 4m spacing and should not discharge over the lower flange of the girder as well as transom / abutment.
2. The lower edge of the scupper pipe should be projected a few inches from the soffit of the deck slab.

1. Accumulation of debris to be avoided on the deck slab.
2. Remove the deteriorated concrete.
3. Apply the bond coat to support the bond amongst the repair work done and the old concrete.
4. It is a usual tradition to use spray-based procedures if the topping of the repair material is between 20-40mm, such as Gunitite with the help of highly skilled workers to certify both good bond and compaction of the material.
5. Cure the material by any appropriate method per recommendations of the manufacturer of the repair material.

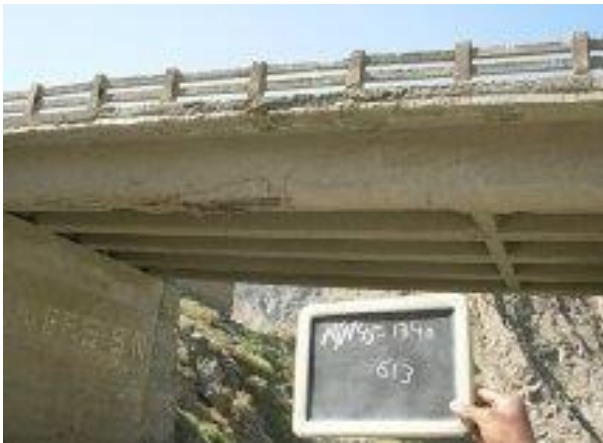
Figure 2 Damage to the Girder

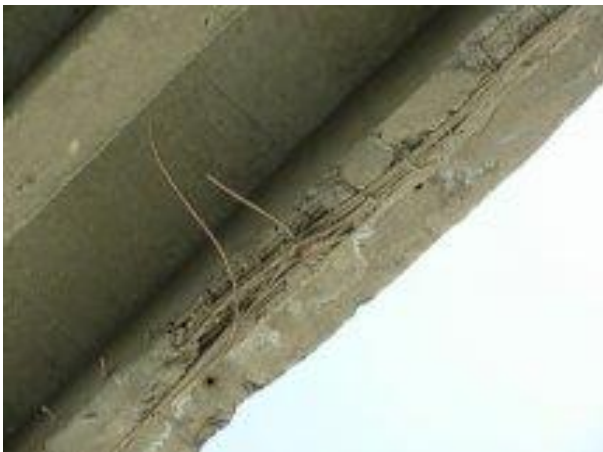
Figure 3 Pre-Stressed strands exposed

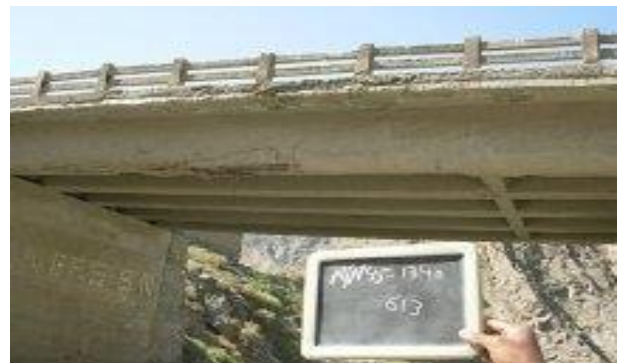
Figure 5 Damage to the Girder

1. The minimum recommended clearance under the flyovers is 5.1m in NHA specification. But this clearance should never be less than 6.0m i.e. an allowance for resurfacing of the underneath roads should be kept in mind.
2. Maximum height of the vehicles should be restricted and warning signs be installed.

1. Remove the deteriorated concrete, clean and straighten the bent bars. If the desired splice lengths are not achieved, the additional bars can be welded.
2. Apply the bond coat to promote the adhesion between the repair and the parent concrete.
3. Use formwork if the thickness of the repair is more than 40mm. It is common to use spray-based methods if the layer of repair material is between 20-40mm, such as Guniting by the help of highly skilled workers to certify both good bond and compaction of the material.
4. Cure the material by any appropriate method per recommendations of the manufacturer of the repair material.

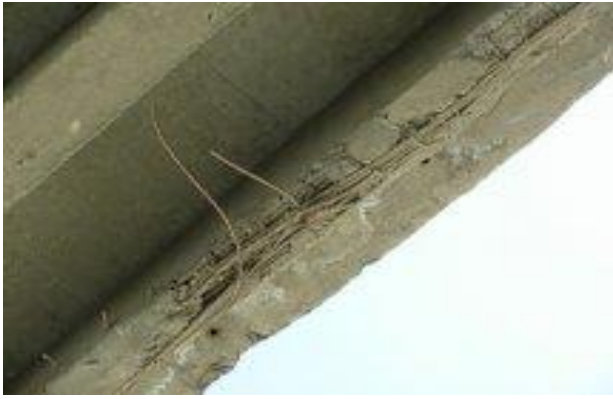
Figure 6 Pre-Stressing Strands Exposed

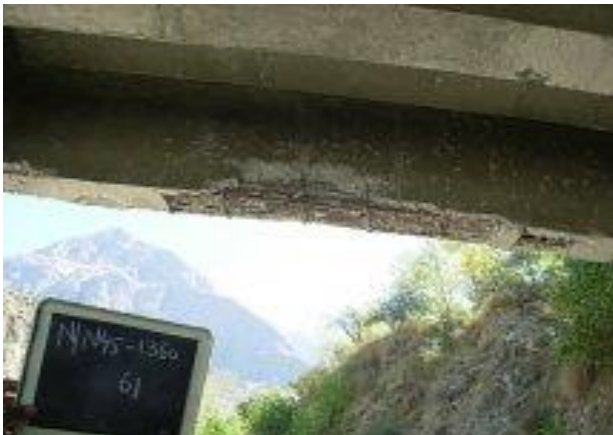
Figure 7 Damage to the Lower side

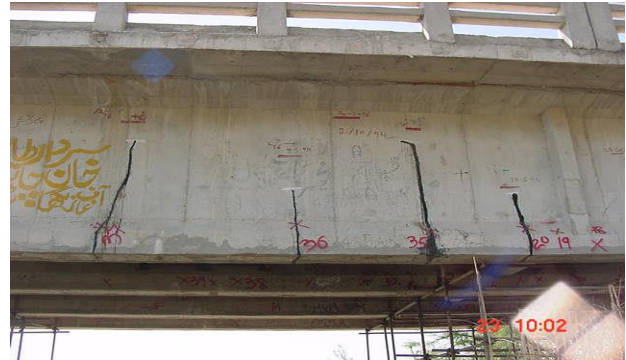
Figure 9 Cracks developed in the web

The solution to this problem is external post-tensioning. This would reduce the deflection in the middle and hence reduce the cracking in the girder in both web and flange section. A typical way of doing so can be seen in figure 5.

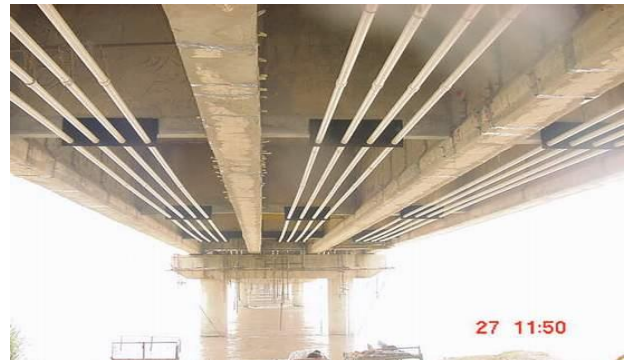
Figure 10 External Post-Tensioning
