RETROFITTING OF SHEAR DEFICIENT INTERIOR SLAB-COLUMN CONNECTIONS IN RC FLAT-PLATES USING EPOXY RESINS

ABSTRACT: This research reports the results of an experimental study on the use of epoxy resins as retrofitting material in the slab-column connections in reinforced concrete flat-plates subjected to concentric loading. Series of experimental tests are conducted on six isolated slab-column connections organized in two groups depending upon their compressive strength ranges. In each series, except for the control specimens, two different techniques for retrofitting of slab-column connections are considered. A constant flexural reinforcement ratio of 1.25% has been used for all the specimens to observe the effect of retrofitting techniques. The slab-column connection strengths are evaluated using ACI 318-11 code equations. From the test data obtained, the equations for interior slab-column connections under concentric loading as a function of concrete strength are developed. The results show that the retrofitting techniques used are effective in enhancing and restoring the load-carrying capacities from 12 to 30% relative to the control specimens.

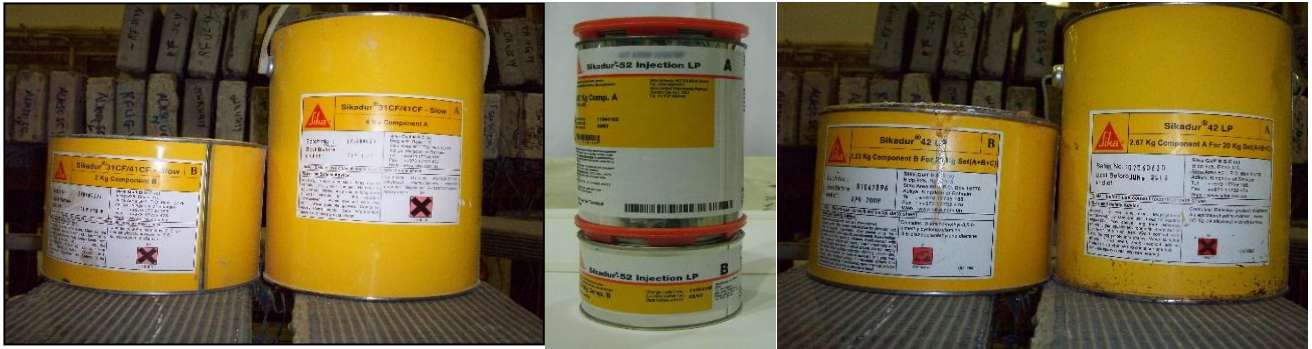
(a) Sikadur 31 (b) Sikadur 52 (c) Sikadur 42

Figure-5: Epoxy resins produced by Sikadur®, Swiss.

Three different types of epoxy resins were used for retrofitting of the test specimens. Each epoxy resin served a specific purpose; for example, 1) thixotropic adhesive mortar based crack sealer epoxy resin was used to prevent leaking from slab bottom faces and around slab-column connections; 2) high strength based pourable grout epoxy resin was used to replace the spalled and damaged concrete in the slab-column connection regions, and 3) low viscosity based crack injection epoxy resin was used to fill the cracks. All the three products were from the Sikadur® and are shown in Figure 5. The properties of epoxy materials used are enlisted in Table-3.

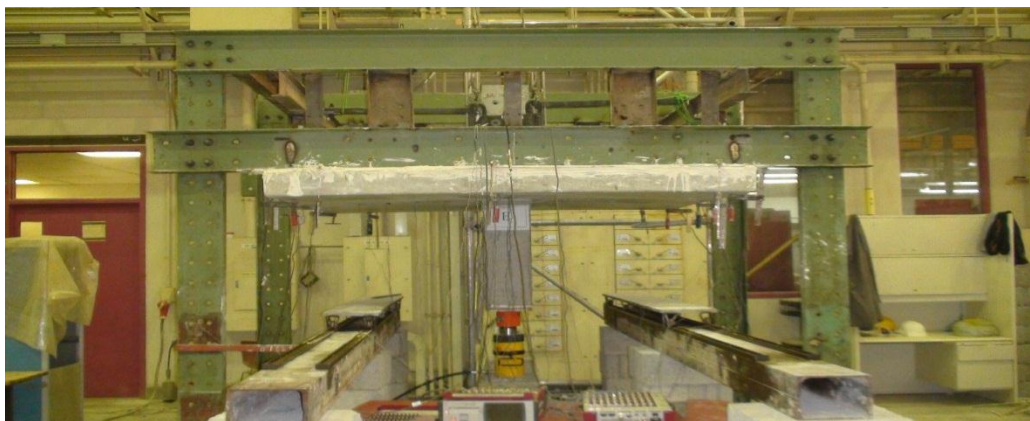
Figure-7: Overall view of test setup assembly with the specimen.

A stiff reaction steel frame was used in the testing of the specimens. A 7.5-ton capacity crane was used to lift and install the test specimens inside the test frame. Prior to the testing, all the specimens were simply supported along all four edges to represent the region of the negative bending moment around an interior slab-column connection. The base of the lower stub column stub was placed on the load cell that was supported by a hydraulic jack of capacity 1000 kN and reacted by a strong test floor of the Structural Engineering Laboratory. To simulate the loading effects that the specimens would experience, a concentric vertical upward pressure was applied and increased monotonically until failure. The photograph of the test setup assembly used is shown in Figure-7.

The test specimens (control and retrofitted) were loaded concentrically through the lower stub columns as shown in Figure-7, until failure to estimate the loading capacity. The ultimate loads at the failure of FP-CON-1 and FP-CON-2 specimens were measured at 313 and 449 MPa, respectively. Based on an assumption that fifty percent of the ultimate load represents a level of load on a structure where retrofitting may be required, initial loads of 156.5 and 224.5 kN were applied to FP-EIR-1 and FP-EIR-2 specimens respectively prior to their strengthening. At this level of loading, due to low concrete strength, the FP-EIR-1 specimen experienced bending cracks followed by the flexural cracks on the tension face of the slab. No such

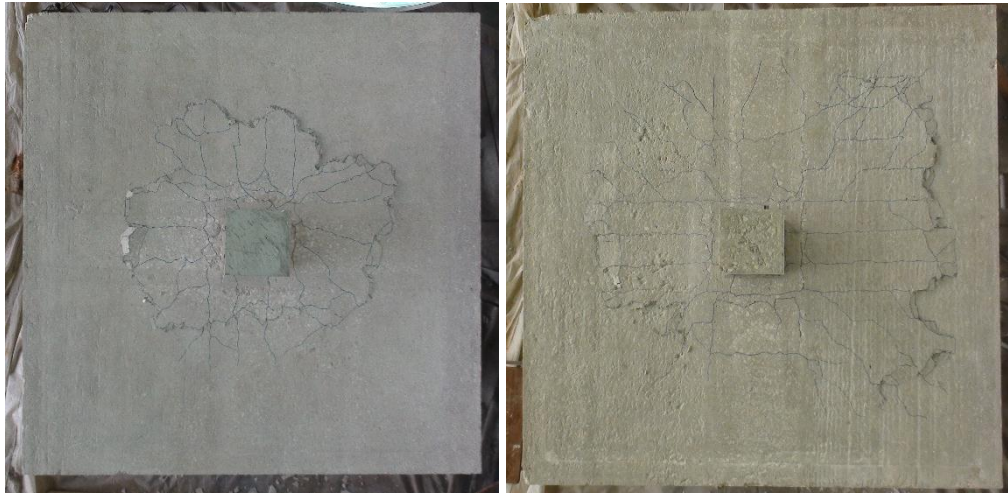
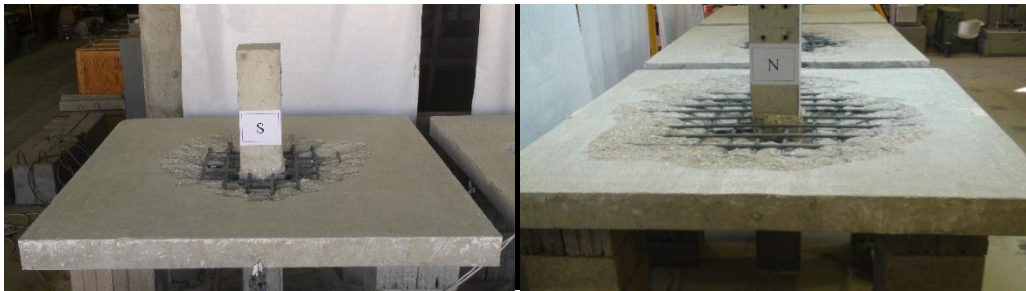
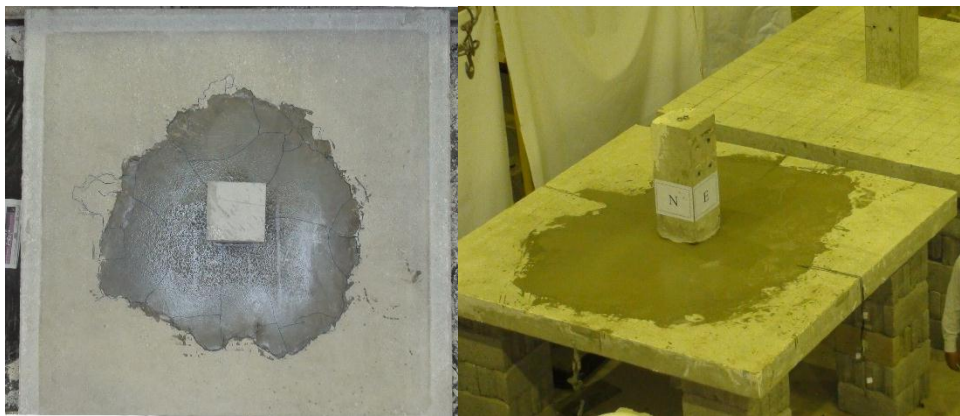
(a) Specimens at first testing

(b) Specimens at the removal of damaged concrete

(b) Specimens after repair

Figure-11: Testing and repairing process of FP-ECR specimens

The configuration of FP-ECR-1 and FP-ECR-2 specimens was similar to their companion specimens in shape, size, and reinforcement ratios. The specimens were first tested to failure, then repaired, and re-tested. Before they were repaired, both the specimens had failed in punching shear with severe cracking radially away from and concentrically around the columns. The spalling of concrete and pushing of the columns through the slabs all took place (Figure 11a). Removal of cement paste to expose the aggregate was required in the area of repair to establish sufficient bonding of epoxy resin to the slab concrete. All the damaged and spalled concrete in the connection regions was crushed using a chisel and hammer and was removed by hand. Using compressed air, the exposed surface of the broken concrete was cleaned and all loose particles were removed out (Figure 11b). In order to prevent leakage of the material, compression faces of the slabs and the column rounds were properly sealed using crack sealer epoxy resin. The paste-over were left for one day for sufficient hardening.

All the area obtained by removal of spalled and damaged concrete in the slab-column connection region was replaced using mixed pourable grout based epoxy resin of flowable consistency. The surface was made leveled and smooth by troweling and was left for three days for ambient curing. Fig. 11c shows a close-up view of slab top surfaces of FP-ECR specimens after repair. The repaired specimens were re-loaded until a second failure took place.

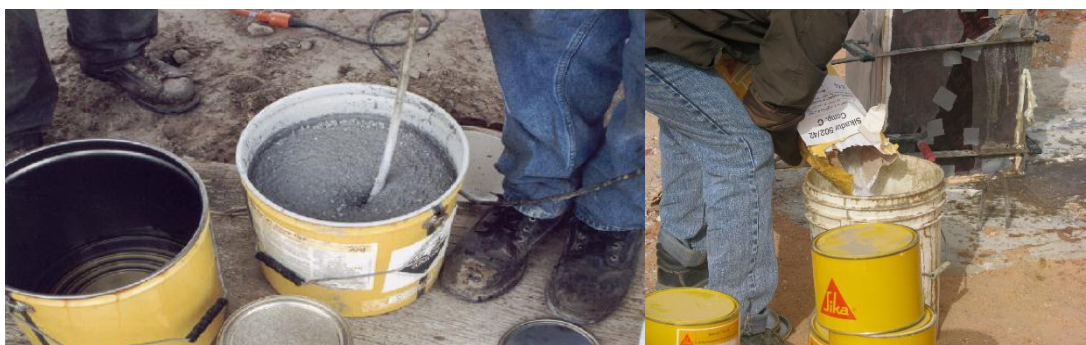
Figure-12: Mixing of high strength pourable grout epoxy resin

A three-component (Part A resin, Part B hardener, and Part C silica sand) pourable grout based epoxy resin was mixed as per manufacturer's instructions. Firstly, Parts A and B were mixed in a mixing bucket using a paddle attached to a slow speed drill (300-450 rpm), until the material became uniformly blended in color and viscosity. After complete mixing of parts A and B, the contents of component C as an aggregate were added and thoroughly mixed until uniform and homogeneous grout was obtained (Figure 12).

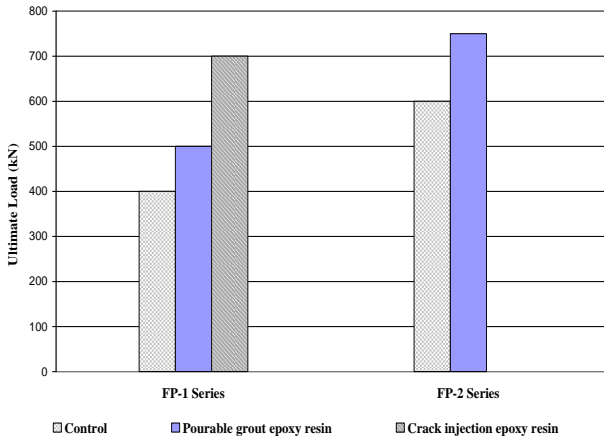
Figure-13: Comparative increase in the ultimate loads

The ultimate load-carrying capacity will be referred to as the load capacity. The ultimate loads obtained for all the specimens are presented in Table 2 and Figure 12. The load capacity of specimen FP-CON-2 was 3% higher than that of specimen FP-CON-1. The ultimate loads increased by 7% for FP-ECR-1 and 11% for FP-EIR-1 specimens as a result of retrofitting compared with FP-CON-1 specimen. A similar trend was observed for specimen FP-ECR-2, retrofitted using high strength pourable grout epoxy resin that showed an increase of 40% in load capacity over that of FP-CON-2 specimen. The concrete strength used in the preparation of specimens of series FP1 was 14 MPa. It is also observed that as the concrete strength was increased from 14 to 28 MPa for specimens in series FP2, the ultimate load increased from 622 to 1363 kN. Hence, it can be concluded that the concrete strength had a strong influence on the punching shear capacity. The ultimate loads obtained for specimens FP-EIR-1 and FP-CON-2 are comparable, that the retrofitting technique in the former resulted in enhancing the load capacity of the under-strength specimen. The high strength pourable grout epoxy resin resulted in increasing the ultimate load in the range of 17 to 45%, whereas the crack injection epoxy resin resulted in increasing up to 28 % over the corresponding control specimens. It is observed that the retrofitting with high strength pourable grout epoxy resin is more effective for specimens with lower concrete compressive strength. The retrofitted specimens have not only carried higher loads but also sustained greater deflections till ultimate stage.
