INVESTIGATION REGARDING BRIDGE BEARINGS DETERIORATION IN PAKISTAN AND ITS REMEDIAL MEASURES

Ali Ajwad¹, Liaqat A. Qureshi², Tariq Ali³, Akhtar Abbas³, M. Ali Khan³ and Waqas Younis⁴

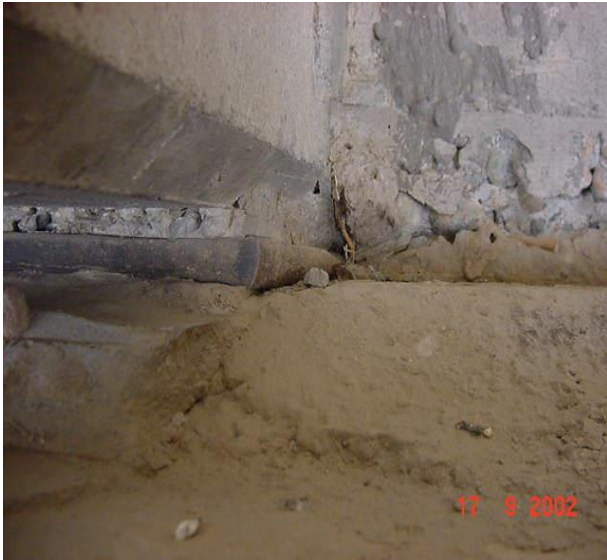
Figure 1 A view showing a failed elastomeric bearing pad observed in Sutlaj bridge

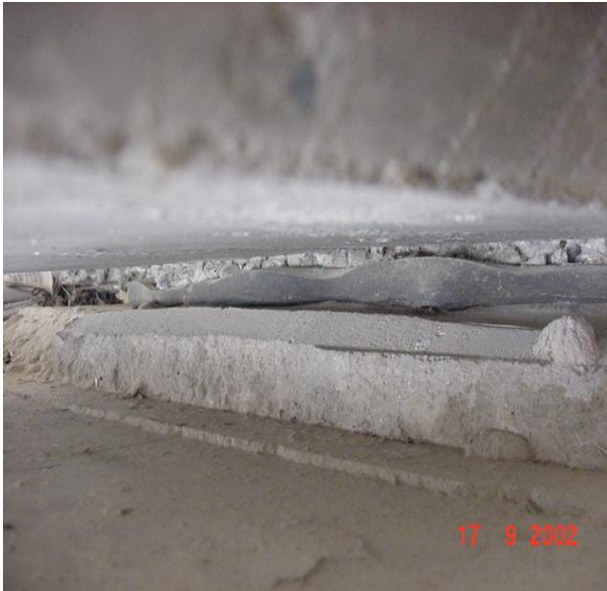
Figure 2 A view showing a failed elastomeric bearing pad observed in Sutlaj bridge

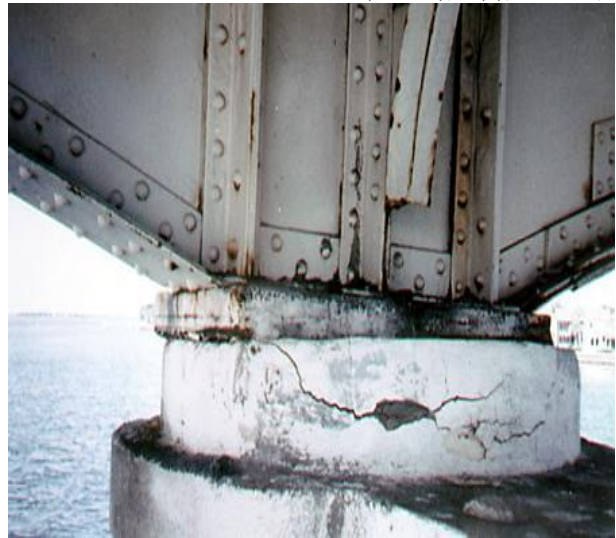
Figure 3 Failure of elastomeric bearing under Steel girders

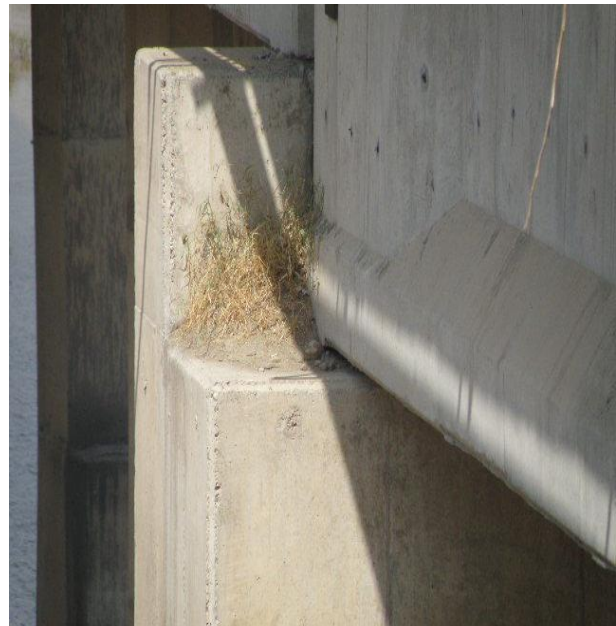
Figure 4 Vegetation near the bridge bearings at Kokbridge on Islamabad Highway

1. If all the above mentioned aspects be taken into account, the desired service life of the bearings and thus the whole bridge can be insured. However, routine inspection and maintenance should be done to avoid growing of vegetation as shown in the figure below;

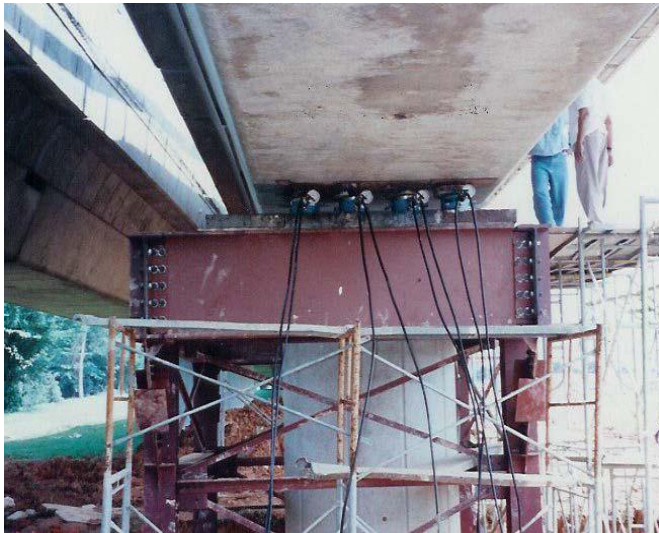
Figure 5 Arrangement for replacement of a mechanical pot bearing of a bridge

2. **Replacement option:** The first thing that needs to be done is to make alternative arrangements for transferring the load from the superstructure to the piers for the whole replacement duration. Usually in such types of scenarios, hydraulic jacks are used to lift the superstructure and the affected bearing is then treated or replaced. This can be done in two ways depending upon the size of the substructure. If the substructure has enough space left on the sides and has the capacity to bear the load of the superstructure at that very point, then the jack can be placed on top of it. If such is not the case then supporting frame has to be erected from the ground making it more expensive. Bearing replacement option requires considerable experience as different aspects such as effective load transfer mechanisms, bearing pressures, balanced gradual lifting, speed of replacement and most important of all the stability of the superstructure needs to be considered carefully.

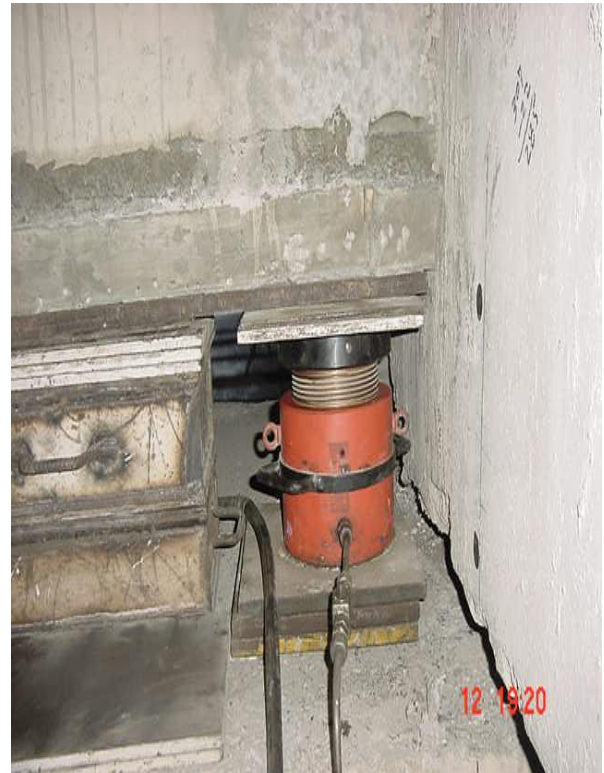
Figure 6 Arrangement for replacement of an elastomeric bearing of a bridge
